Vehicle Specific Clutch Kit Installation Notes

TBC24

Relates to: R2002N, RPM200N2
HOLDEN COMMODORE / CALAIS VX (2001 – 2002)
HOLDEN COMMODORE / CALAIS / MONARO VY/V2 (2002-2004)

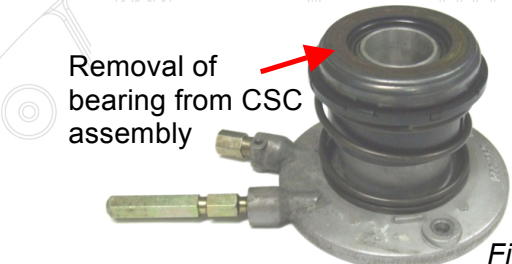
<p>Step 1: When transmission is removed from vehicle remove the bearing and spring.</p> <p><i>Figure 1) CSC assembly</i></p>

<p>Removal of bearing from CSC assembly</p> <p><i>Figure 1)</i></p>
<p>Step 2: When bearing has been removed from CSC assembly inspect the back of the bearing. If Seal is present proceed as normal with new bearing installation.</p> <p><i>Figure 2) Shows used bearing with no seal.</i> <i>Figure 3) Shows a new bearing with seal.</i></p> <p>Note: Seals range in colour from blue, white and black</p>

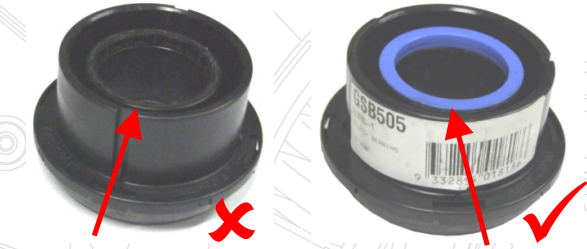
<p><i>Figure 2) No Seal</i> <i>Figure 3) Blue Seal present</i></p>
<p>Step 3: If no seal is on the back of the bearing proceed to inspect the bore of the CSC.</p> <p><i>Figure 4) Shows the seal at the bottom of the CSC bore.</i></p> <p>Note: In many situations the seal will be difficult to see due to grease concealing its presence.</p>

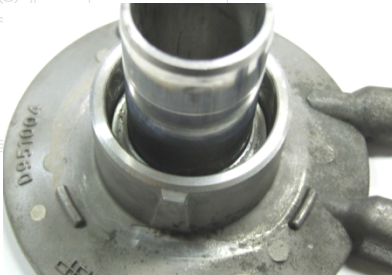
<p>White coloured seal at bottom of CSC bore</p> <p><i>Figure 4)</i></p>

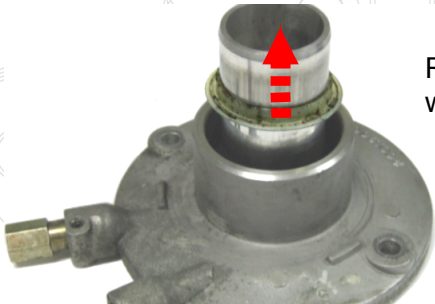
<p>Removal of white seal</p> <p><i>Figure 5)</i></p>

<p>Step 4: With the aid of a thin flathead screwdriver remove the seal. Proceed as normal with new bearing installation.</p>
